CASE STUDY

RIVER EMBANKMENT

Environment
Agency

RIVER EMBANKMENT, ENVIRONMENT AGENCY

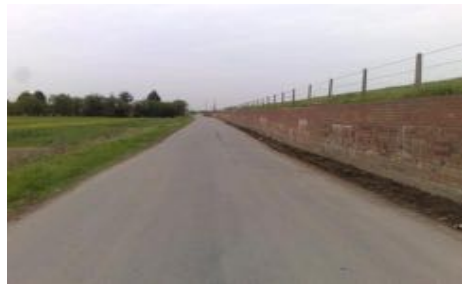
Several methods were utilised to demonstrate the efficacy of the process. Visual observations following installation demonstrated that the adjoining road and fields rapidly dried out. No water egress was observed through the embankment wall as shown in Figure 6. Borehole sample cores were taken along the barrier installation and analysed / evaluated to confirm compliance with target objectives (see Figure 7). All core samples demonstrated effective mixing with permeability values less than 10-9m/s. WVG also installed a series of boreholes complete with data loggers which demonstrated that the barrier was functioning in accordance with the design. The complete barrier installation is shown in Figure 8.

Figure 6 - Adjacent road following installation. Significant improvement compared with Figure 2.

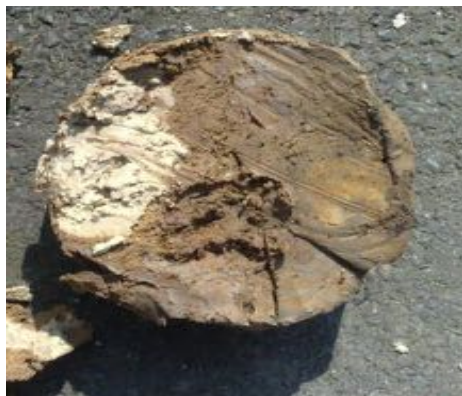
Figure 7 - Borehole Core. Showing Bentonite Plugging.

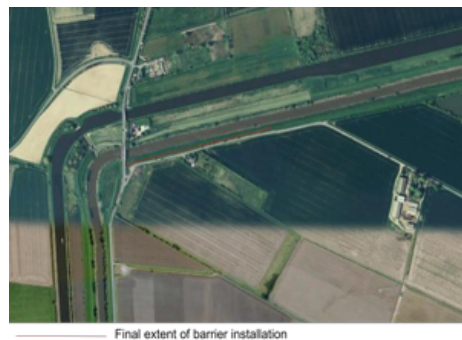
Figure 8 - Location and Extent of Complete Embankment Barrier Installation.
